To: gencaa@mail.caa.gov.tw/
From: John Barry Smith <barry@qp6.com>
Subject: China Airlines Flight 611 alternative explanation
Cc:
Bcc:
X-Attachments: :MrX:158673:81192/02.pdf:

Dear Mr. Chang, Tuesday, March 8, 2005 10:12PM

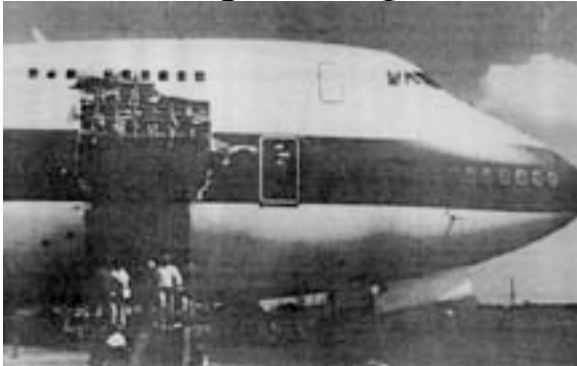
May I first present the evidence from China Airlines Flight 611 which supports the wiring/cargo door explanation because it matches United Airlines Flight 811, picture below.

United Airlines Flight 811 was the Boeing 747 that had its forward cargo door inadvertently open in flight in 1989 after takeoff from Honolulu leading to explosive decompression and nine fatalities. "The National Transportation Safety Board determined that the probable cause of this accident was the sudden opening of the forward lower lobe cargo door in flight and the subsequent explosive decompression. The door opening was attributed to a faulty switch or wiring in the door control system which permitted electrical actuation of the door latches toward the unlatched position after initial door closure and before takeoff."

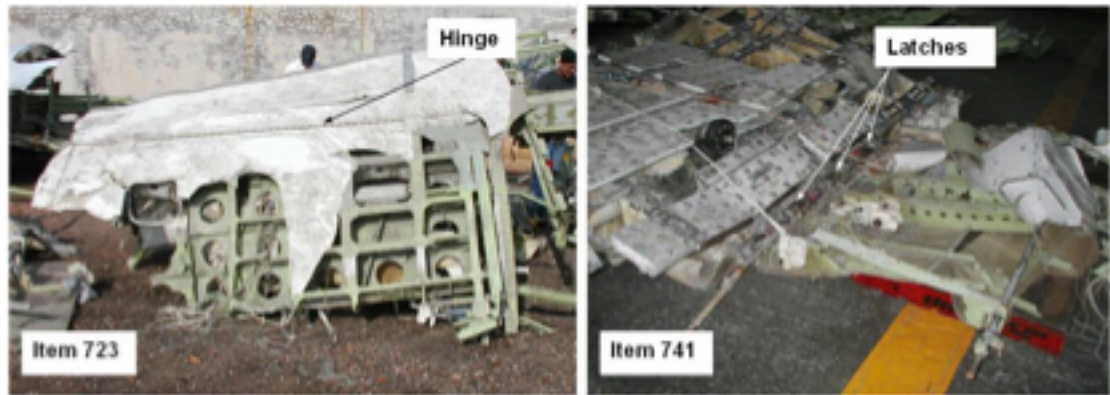
Figure 1.12-4 Item 723 (left) and item 741 (right)

"1. Aft Cargo Door The aft cargo door was retrieved in the red zone in three major segments. The upper portion of the door (item 723 in Figure 1.12-4 left) was recovered with the hinge intact and the actuators in the closed position. The lower portion of the door (item 741 in Figure 1.12-4 right), including three forward pairs of latches, was recovered still latched and the locks engaged. Only a few pieces of the skin and stringers remained on the frames. The lower aft portion of the door (item 2019 in Figure 1.12-5), including the aft pair of latches, was found separately. The lower portion of the door skin was bent outboard approximately in 45 degrees. Examination of the hinge, latches, and the other mechanisms was consistent with the aft cargo door being closed at the time of the aircraft breakup."

Mr. Chang, the above conclusion by the ASC that the aft cargo door was closed at the time of the aircraft breakup is contradicted by the facts of the evidence. A cargo door retrieved in three main pieces far apart in the debris field did not 'remain intact when the aircraft broke up.' The ASC conclusion about ruling out the aft cargo door is proven wrong.

- Furthermore:
1. The door was shattered into three main pieces which landed far apart and early in the debris field which indicated the door pieces left early in the destruction process.
 2. The top half of the aft cargo door was split longitudinally with hinge intact similar to the United Airlines Flight 811 cargo door which ruptured open in flight.
 3. There are eight latches and eight locking sectors on the bottom of the door, only five were found for China Airlines Flight 611.
 4. There are two midspan latches, forward and aft with no locking sectors, neither of those midspan latches were recovered.
 5. The cargo door has a manual locking handle which was not recovered for examination for China Airlines Flight 611.
