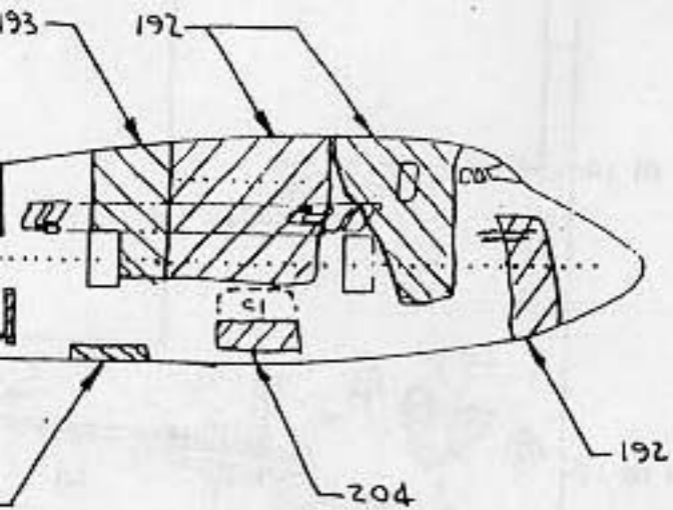
All cargo doors were found intact and attached to the fuselage structure except for the forward cargo door which had some fuselage and cargo floor attached. This door, located on the forward right side of the aircraft, was broken horizontally about one-quarter of the distance above the lower frame. The damage to the door and the fuselage skin near the door appeared to have been caused by an outward force. The fractured surface of the cargo door appeared to have been badly frayed. Because the damage appeared to be different than that seen on other wreckage pieces, an attempt to recover the door was made by CCGS John Cabot. Shortly after the wreckage broke clear of the water, the area of the door to which the lift cable was attached broke free from the cargo door, and the wreckage settled back onto the sea bed. An attempt to relocate the door was unsuccessful.
